Utilizing Unmanned Aircraft Systems (UAS) for Bridge Inspections

IBTTA 2016

Phase I Project Background

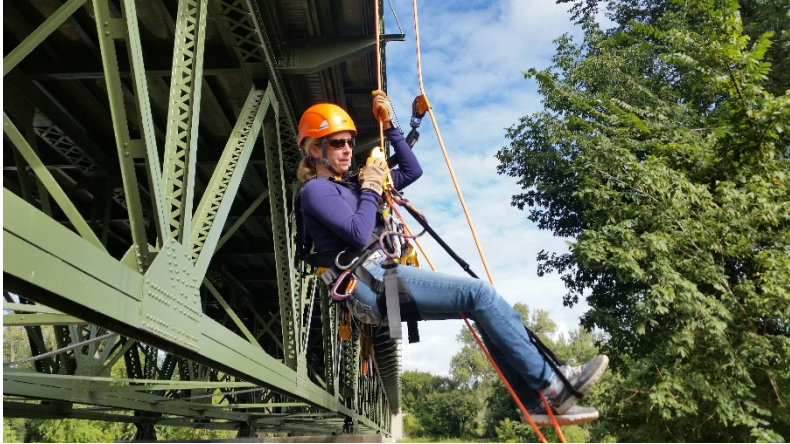
Access Methods

- Aerial Work Platforms (AWP's)
- Rope Access and Structure Climbing
- Ladders

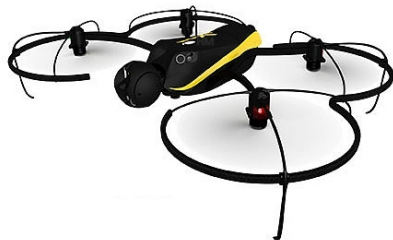
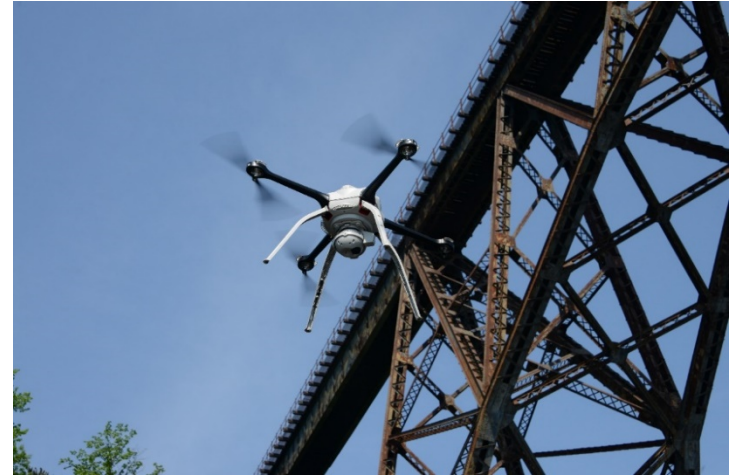
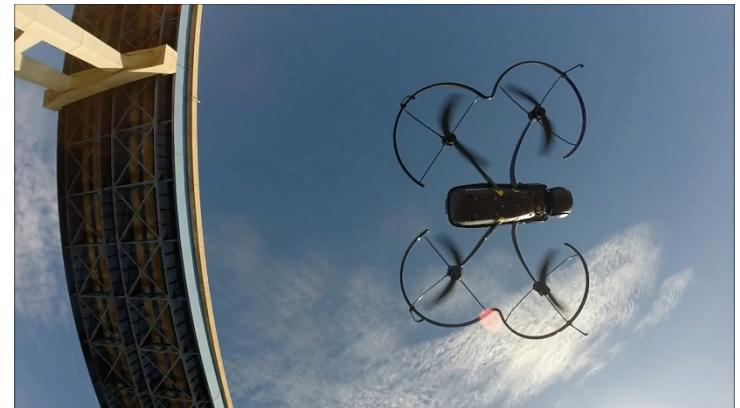
Assessment of UAS Technology

- Phase I Technology
 - Not capable of looking up
 - Unable to fly without GPS
 - Photo, Video and Thermal Imaging
- Phase II Technology
 - Inspection-specific UAS
 - Object Sensing
 - Capable of looking up
 - Fly without GPS, under bridge decks
 - Photo, Video and Thermal Imaging

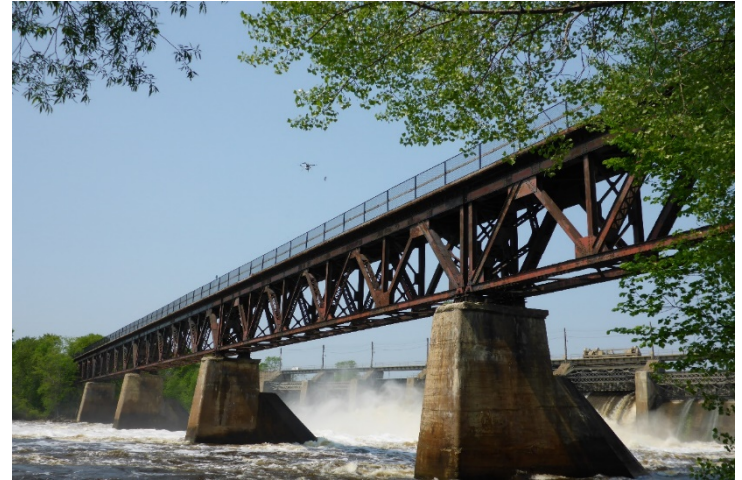
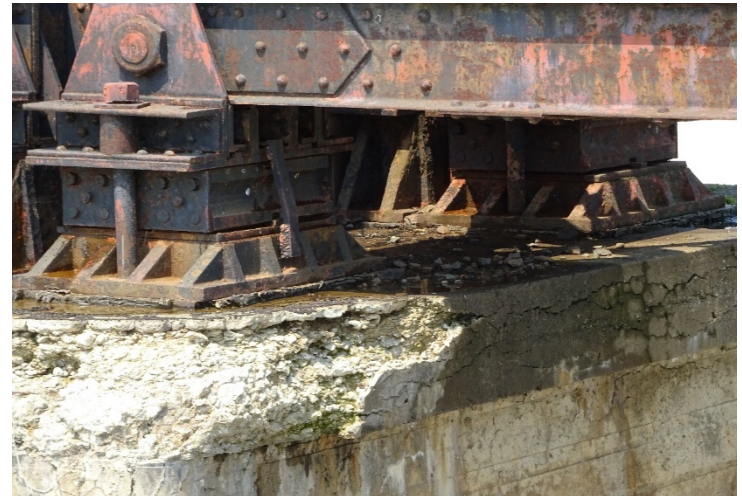
Bridge 49553 –Morrison County Pedestrian Bridge

- Large Steel Truss
- Difficult to access with UBIV
- Great detail in images
- Pack rust visible
- Concrete deterioration visible

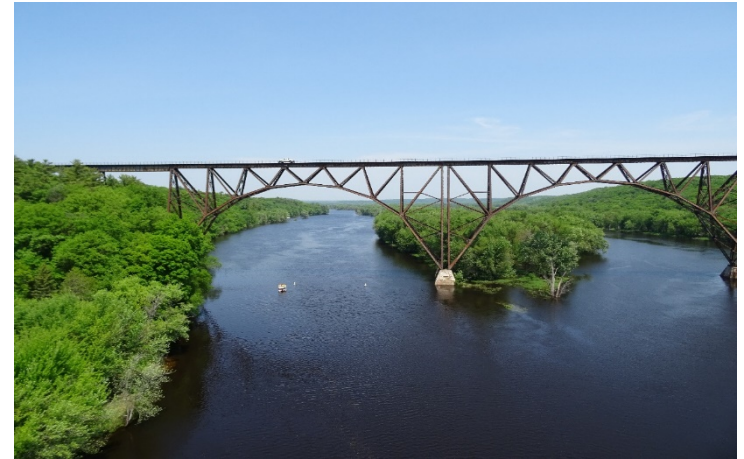
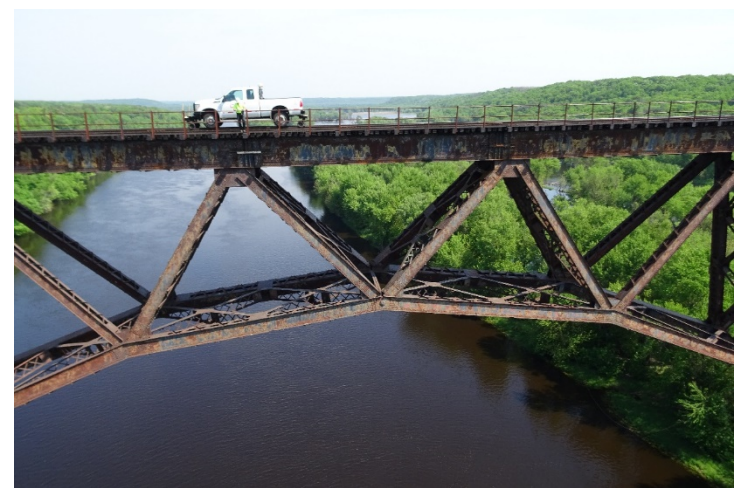
Arcola Railroad Bridge

- Large Complex Bridge
- Normally inspected using rope access
- National Park Service Permission
- Difficult to access

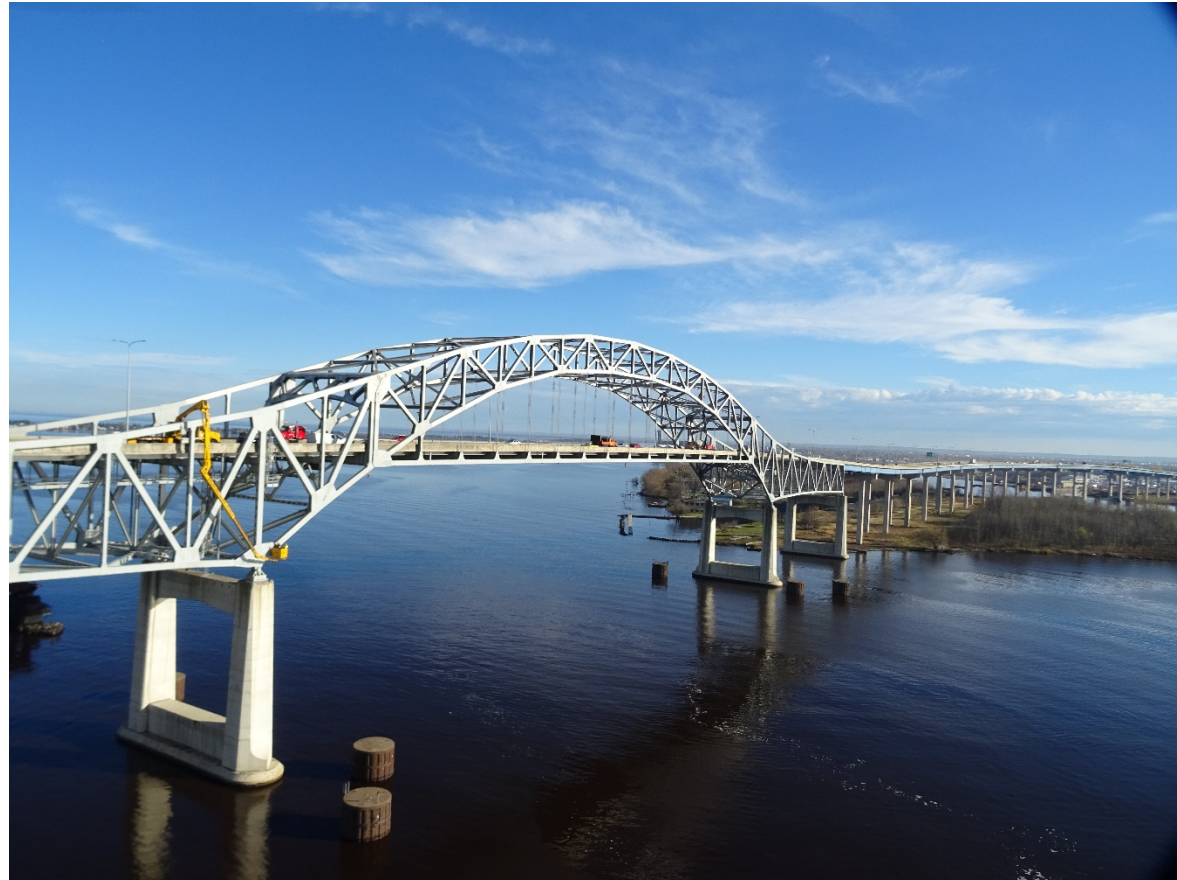
Blatnik Bridge Inspection

- Largest Bridge in Minnesota
- Crosses Duluth Harbor adjacent to Lake Superior
- Challenging wind and weather

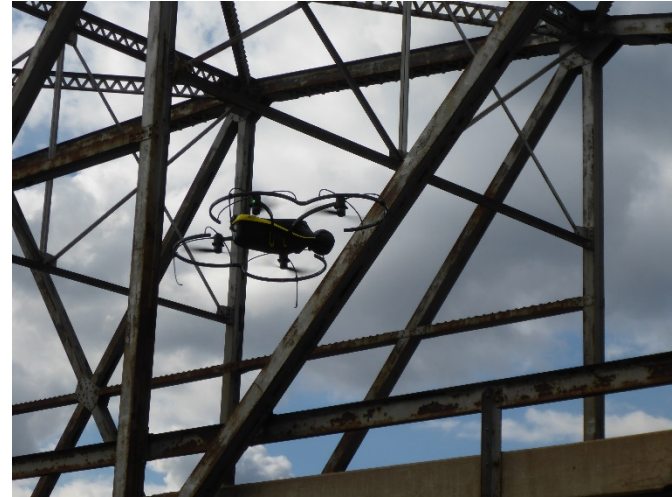
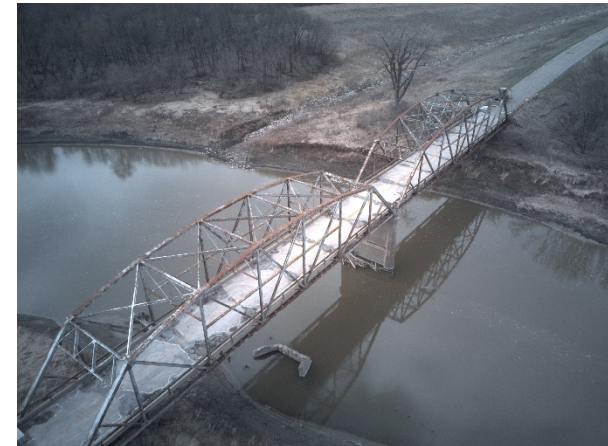
Nielsville Bridge 5767

- Infrared Imaging
- Thermal Camera results were similar to high end Flir cameras
- Drone has the ability to map chain drag markings for quantities in CAD
